# Manhole Inspection Summary

Manhole # S27A1\_008MH

Insp Date: **4/18/08 2:49 PM**

**Location** Address: **2201 Manokin St**

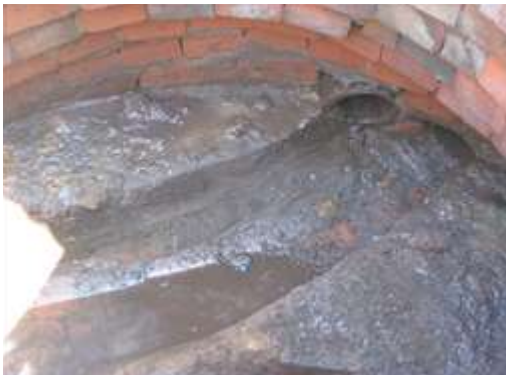
MISCELLANEOUS

mud diposits on bench and in channel

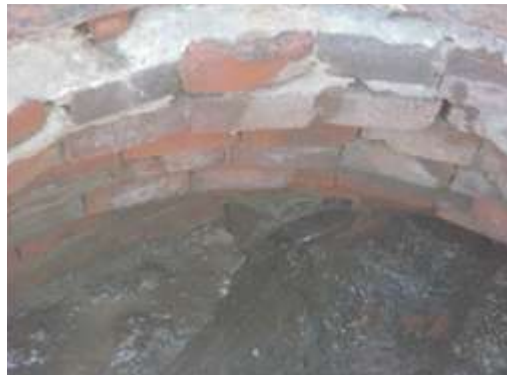
Defect 5

infiltration from mortar in corbel

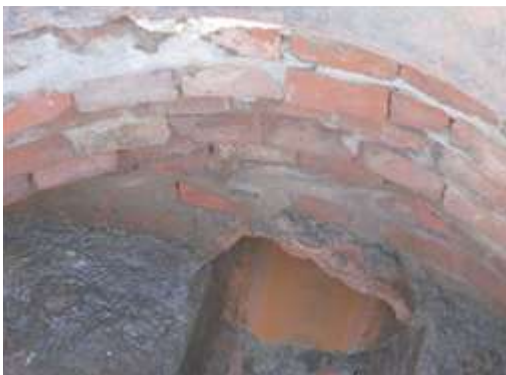
Defect 2

Barrel infiltration

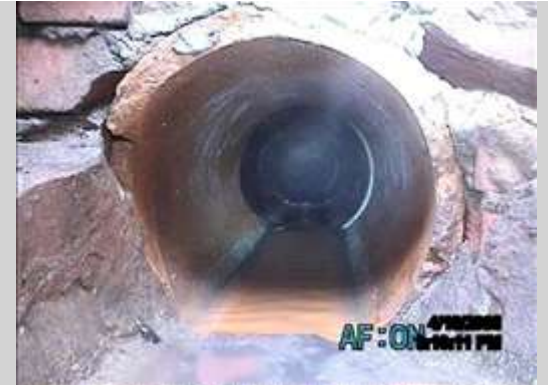
12 O'Clock Outflow

10 in. Circular Gravity Sewer  
Pipe Out @ 12 O'Clock

Pipe Height: **10.8** (in.) Rod and Bar (Angled)  
Pipe Material: **Clay** ☐ Pipe Lined  
Invert Depth: **3.25** (ft.) Flow Characteristics: **Slow**  
Deposits: ☒ None ☐ Mud ☐ Sludge ☐ Debris ☐ Grease  
Silt Depth: **0** (in.) Deposits Extent:  
Infiltration: **Evidence** Pipe Seal Cond: **Cracked**

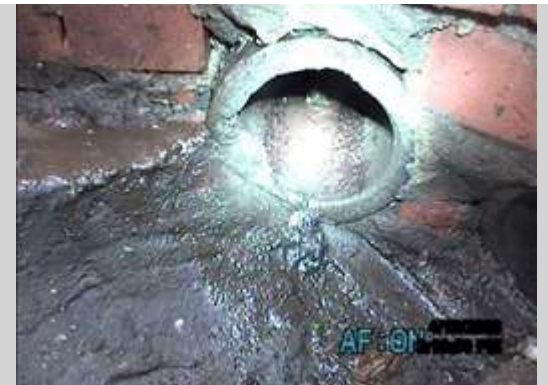
4 O'Clock Inflow

4 in. Circular Gravity Sewer  
Pipe In @ 4 O'Clock

Pipe Height: **4.8** (in.) Rod and Bar (Angled)  
Pipe Material: **Clay** ☐ Pipe Lined  
Invert Depth: **3.12** (ft.) Flow Characteristics: **None**  
Deposits: ☒ None ☐ Mud ☐ Sludge ☐ Debris ☐ Grease  
Silt Depth: **0** (in.) Deposits Extent:  
Infiltration: **Evidence** Pipe Seal Cond: **Unknown**

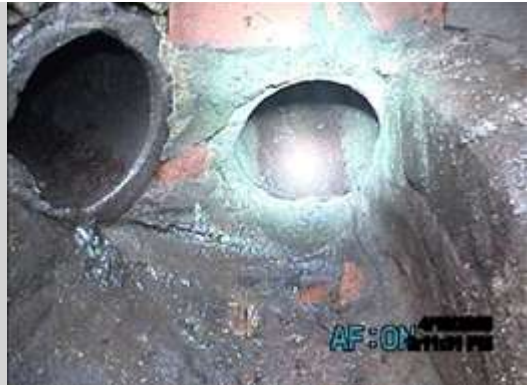
5 O'Clock Inflow

Infiltration: **Evidence**

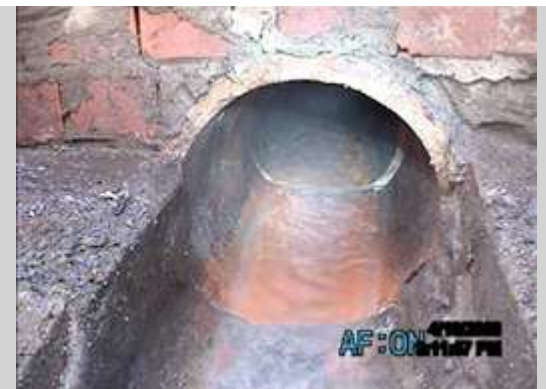
6 O'Clock Inflow

Infiltration: **Evidence**
